RARITAN RIVER BASIN  
SOUTH BRANCH RARITAN RIVER  
HUNTERDON COUNTY  
NEW JERSEY

# LAKE SOLITUDE DAM NJ 00123

## PHASE 1 INSPECTION REPORT NATIONAL DAM SAFETY PROGRAM

May, 1979

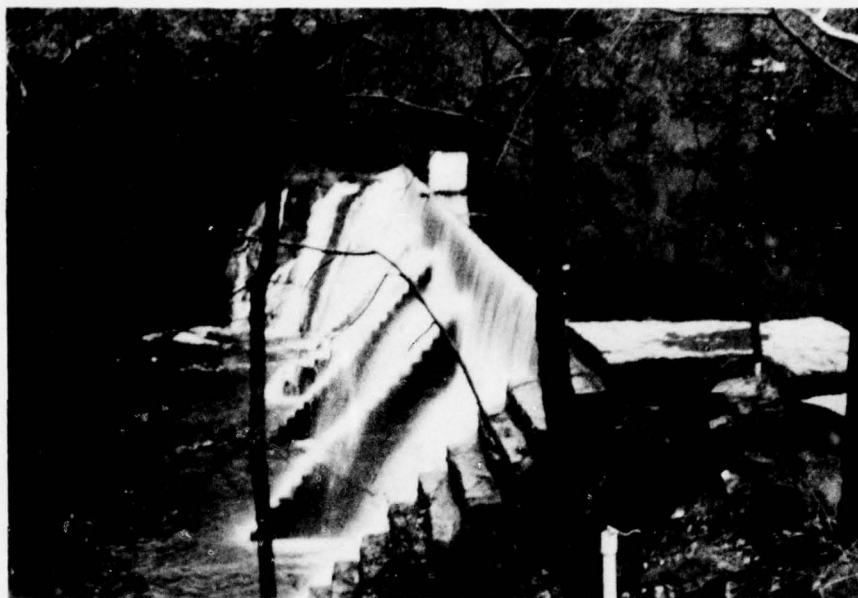
Photo 1 View of masonry dam from left abutment

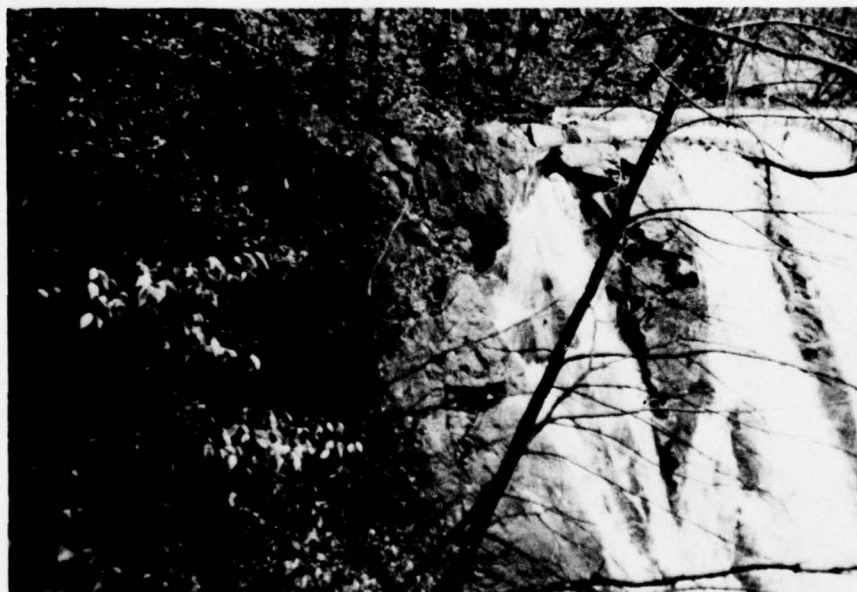
The right abutment of the dam has been constructed in a notch cut into the bedrock. Because the overlying soil was not excavated at a stable slope angle, it has continued to slough into the excavation and a scrap approximately 20 feet wide by 15 feet high has developed in the overburden. The soil cover is potentially unstable, but this condition probably does not threaten the structural stability of the dam. However, the slope adjacent to the right abutment should be monitored for possible movement.

Photo 2 View of right abutment of masonry dam  
looking upstream

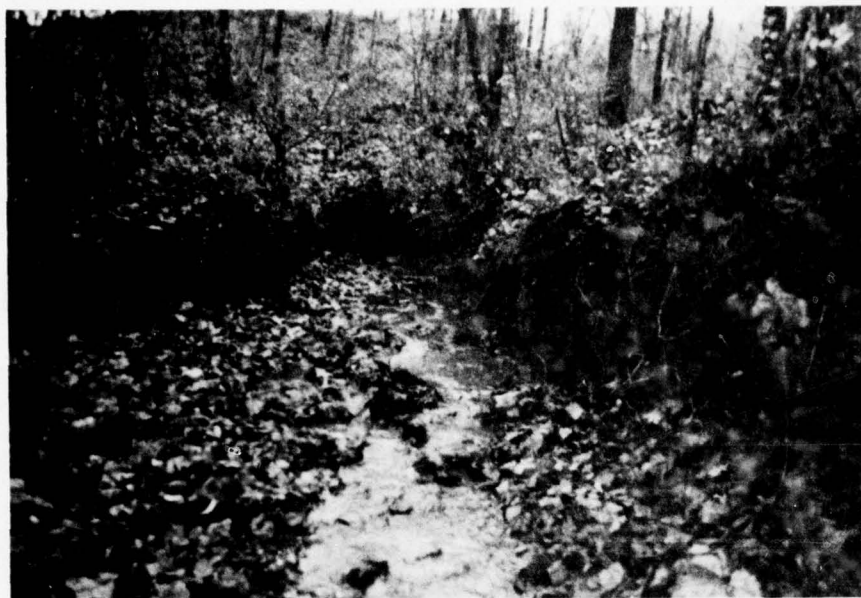
Photo 5 View of tunnel outlet channel looking upstream

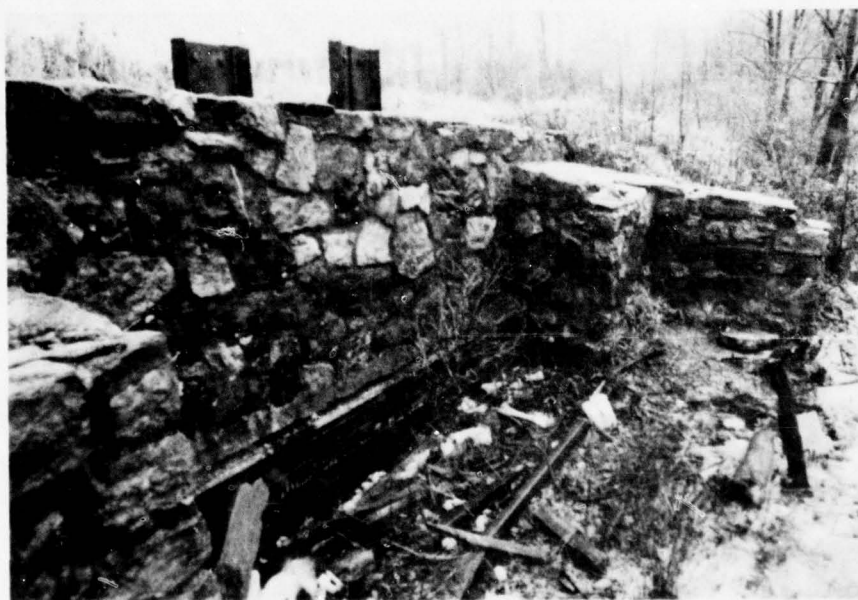
The third outlet was the water supply for the now abandoned hydroelectric power plant (Plate 2). The intake consists of a masonry structure located on the left third of the embankment with sliding gate and steel grate trash cover. The intake is almost completely blocked by sediment and debris (Photo 6). The masonry structure is generally in fair condition with a few dislodged stones, however, the gate which is guided by two steel channels is inoperable.

Photo 6 View of intake to penstock

- 6) The intake to the penstock should be thoroughly sealed off as soon as possible.
- 7) A program of inspection of the dam during and after floods and annually should be initiated, and timely repairs be made.

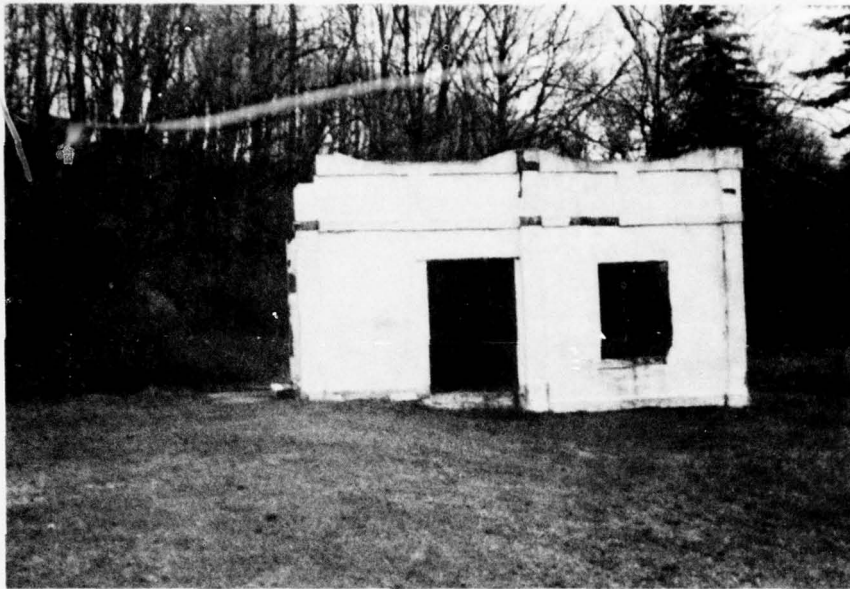
The 6-foot diameter steel penstock exits from under the embankment adjacent to the abandoned concrete power house (Photo 7). The steel is badly corroded and a jet of water was leaking from a hole rusted out at the base of the penstock where it goes underground to connect to the power house (Photo 8). A jet of water was also noted coming out of a hole in the turbine (Photo 9).

Photo 7 View of hydro-electric power plant with  
penstock at left

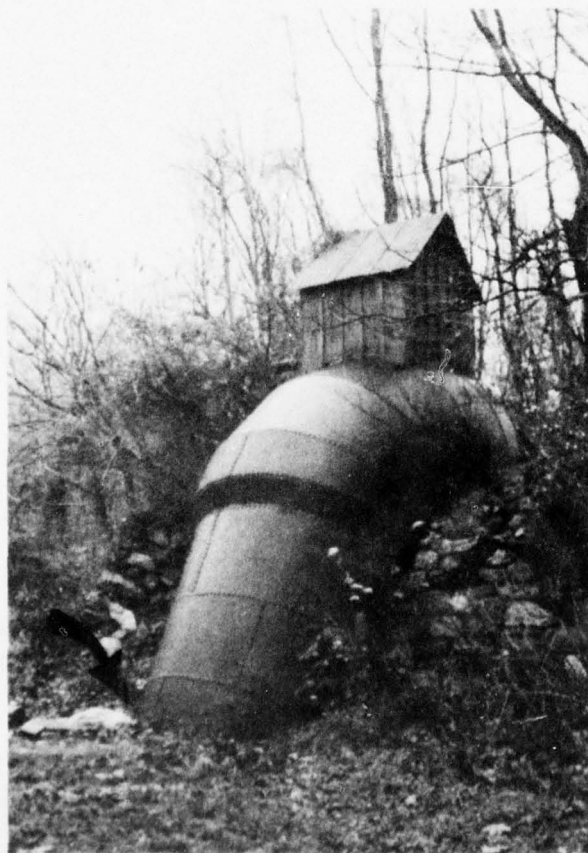
in the masonry section of the dam when water is flowing over the spillway, even if the outlet were operable. Further corrosion of the penstock could result in complete failure of this structure and possible breach of the embankment section.

Photo 8 View of penstock  
showing leak  
(arrow)

(5) The poor condition of the penstock could result in complete failure of this structure either at its downstream end or within the embankment. Water should be prevented from passing into the penstock by thoroughly sealing its intake.

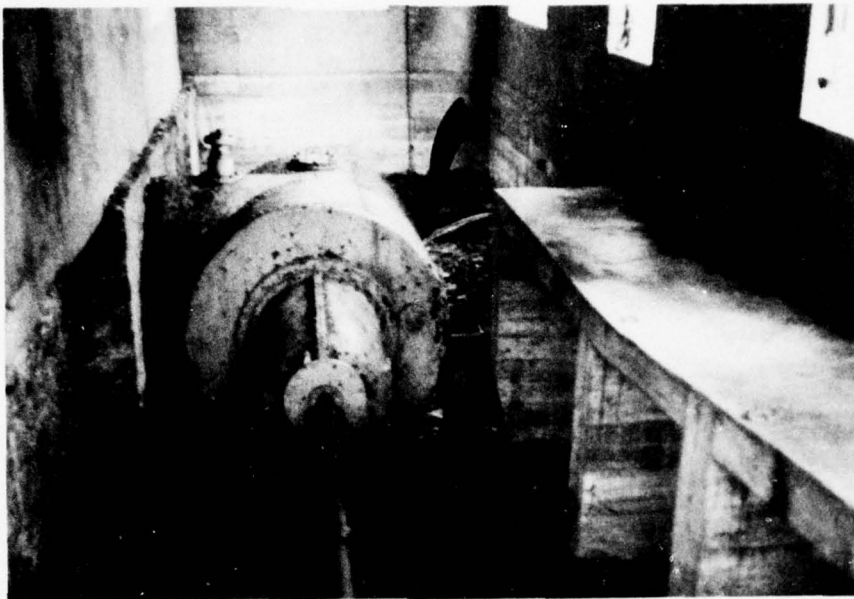
Photo 9 View of turbine inside power house showing leak (arrow)

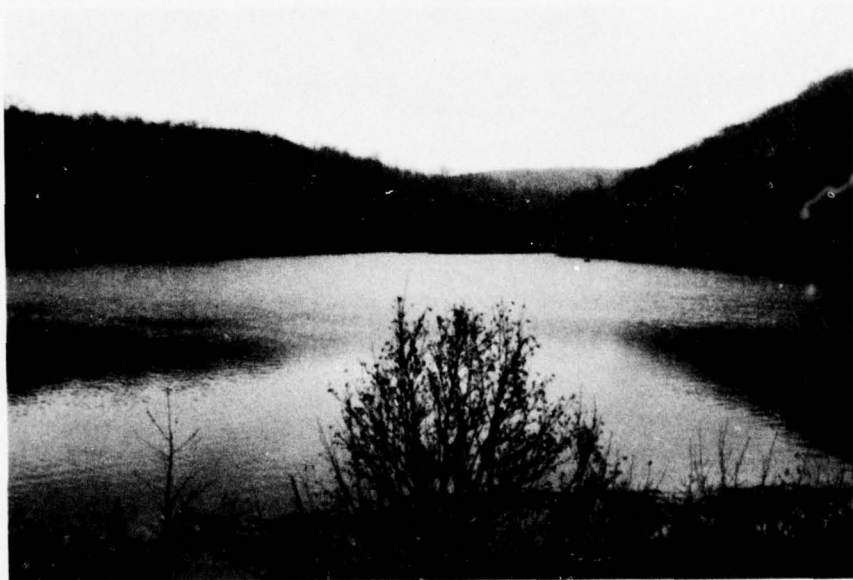
The water was clear and there was no noticable debris or indication of excessive sedimentation, except as noted at the intake to the penstock.

Photo 10 View of reservoir looking upstream

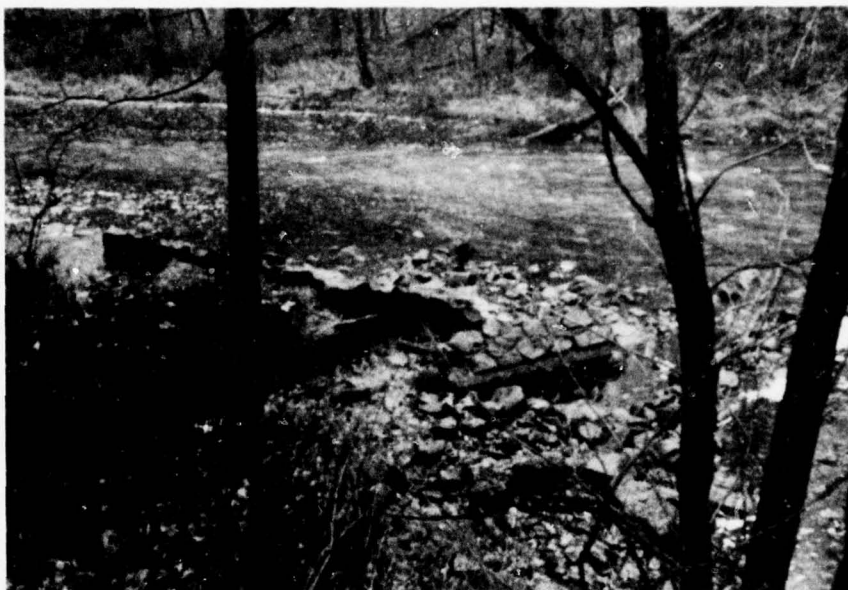
Broken sections of what appear to be a training wall were noted on the left bank of the downstream channel where the stilling pond narrows into the channel (Photo 11).

Photo 11 View showing training wall on left bank of downstream channel

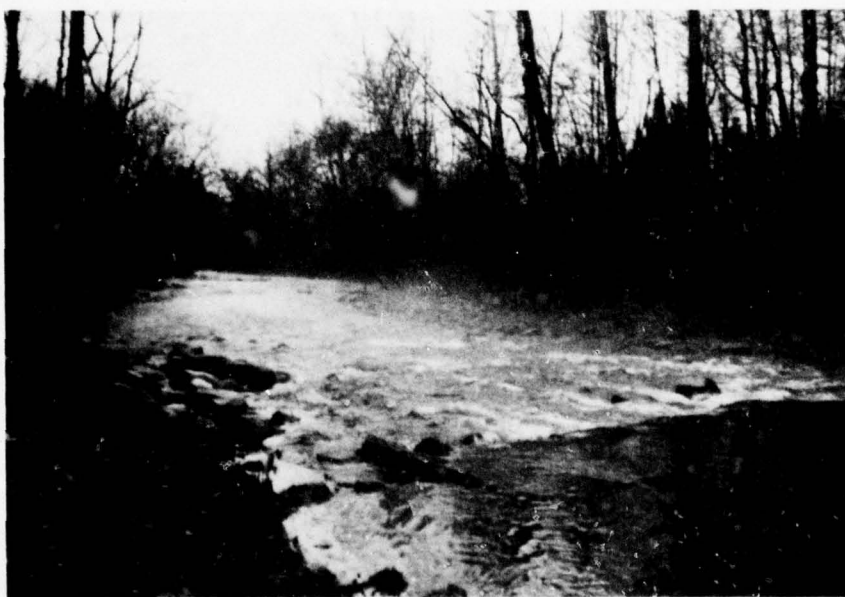
Photo 12 View of downstream channel looking downstream

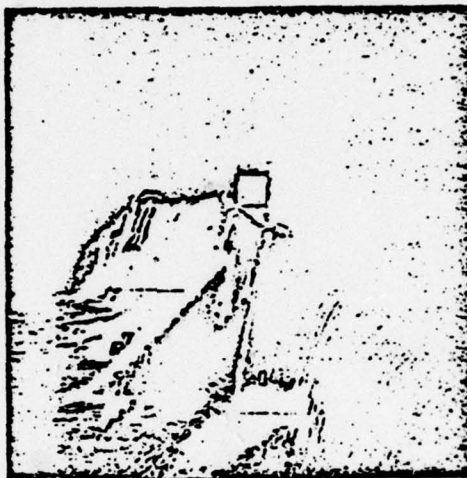
PHOTOGRAPH 2

Constructed on top of the spillway is a white shed which appeared to contain gates and valves. This could not be inspected because there was no access to it from the banks. This is shown in photograph 2.
